### Industrial Storm Water Inspection Report

Entity: Exide Technologies (Exide)	WDID No. <b>Not Available</b>	Inspection Date: 2/16/2011
Facility Name: Los Angeles Recycling Facility	SIC Code: 3341 – Secondary Smelting and Refining of Nonferrous Metals 5093 – Scrap and Waste Materials	Receiving Water: Unknown by Facility Representatives
Facility Address: 2717 South Indiana Street, Vernon; Los Angeles County, California		
Facility Representatives/Titles: Ed Mopas (Environmental Manager, Exide); Vianey Mendez (Health and Safety Manager, Exide)		
Additional Persons Present: Carmelita Benitez (Air Quality Inspector II, South Coast Air Quality Management District)		Inspector(s): Scott Coulson (PG Environmental, LLC)
Weather Conditions at the Time of the Inspection: Sporadic Precipitation

Exide  
Los Angeles Recycling Facility  
Los Angeles County, California

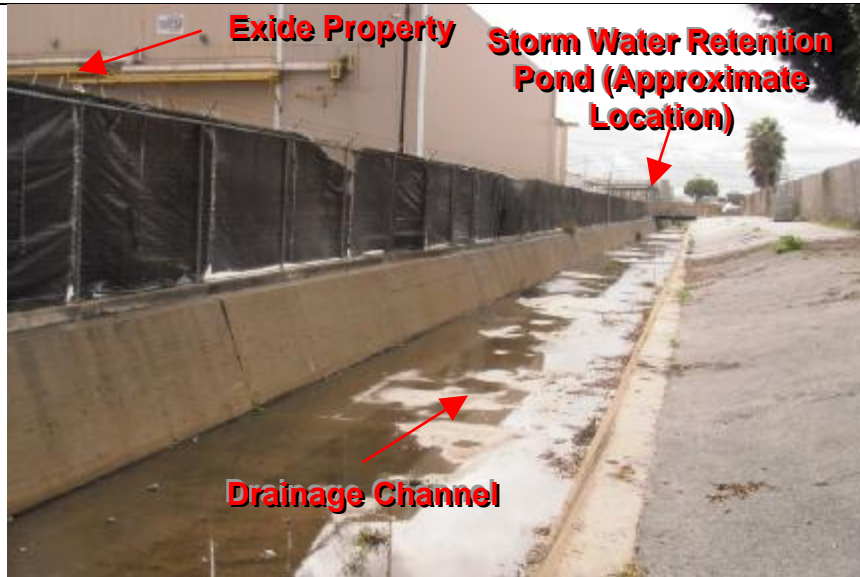
Exhibit 1 provides a site plan layout showing pertinent locations at the Facility. The EPA Contract Inspector observed a drainage channel that serves as the western border of the northern portion of the Facility (refer to Exhibit 1 and Photograph 1),

Photograph 1 – View facing southwest at drainage channel that serves as the western border of the northern portion of the Facility.

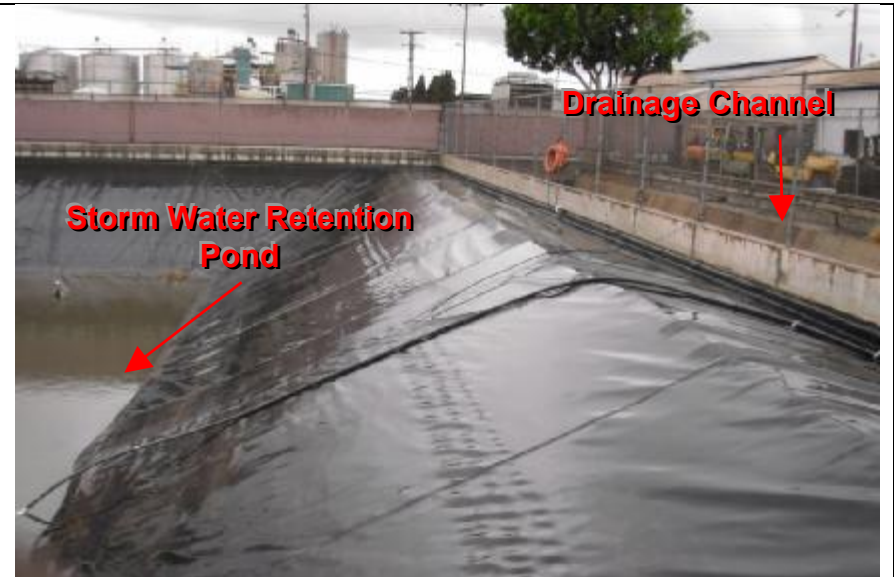
which subsequently flows south and bisects the southern portion of the Facility (refer to Exhibit 1 and Photograph 2). The outfall from the drainage channel to the Los Angeles River is located approximately 0.11 mile to the southwest.

Photograph 2 – View facing southwest at drainage channel that bisects the southern portion of the Facility.

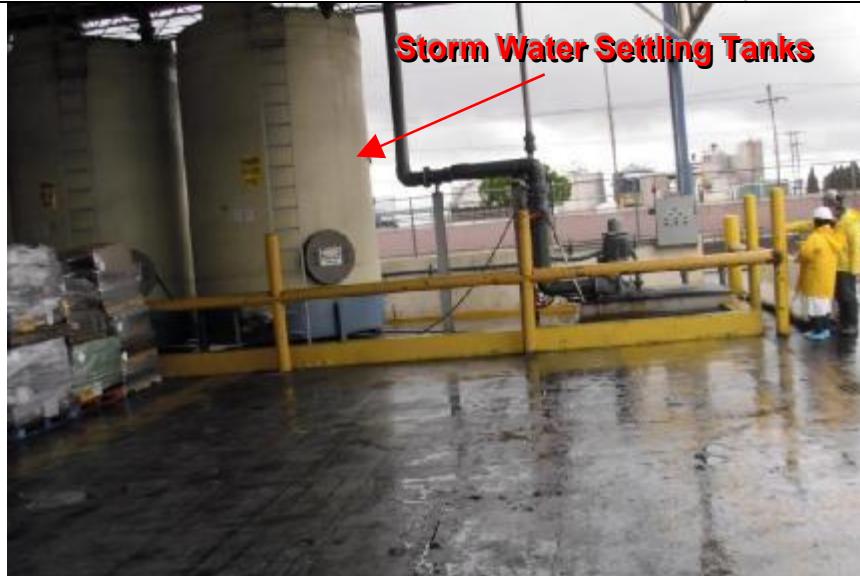
Photograph 3 – Series of four storm water settling tanks (approximately 10,000 gallons each) that are used to feed storm water into the WWTP.

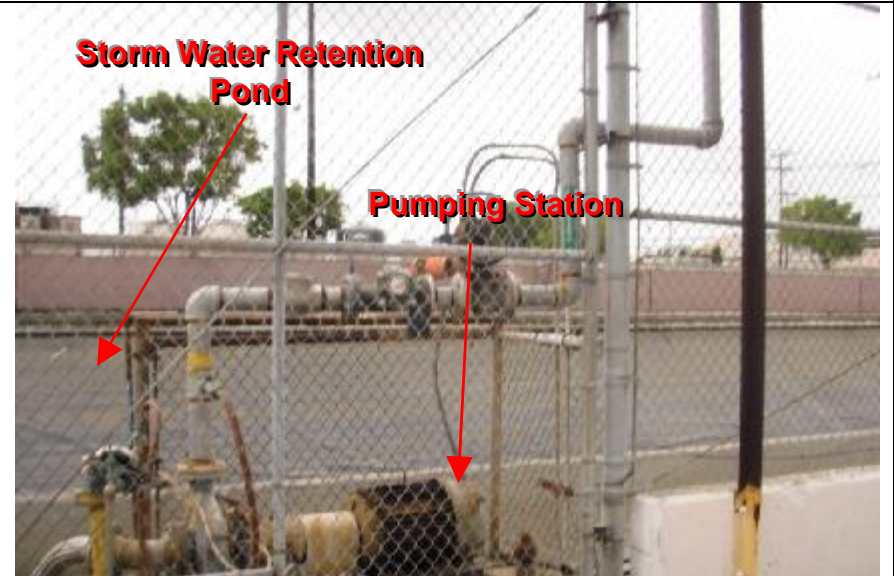
Photograph 4 – A pumping station located near the northeast corner of the storm water retention pond.

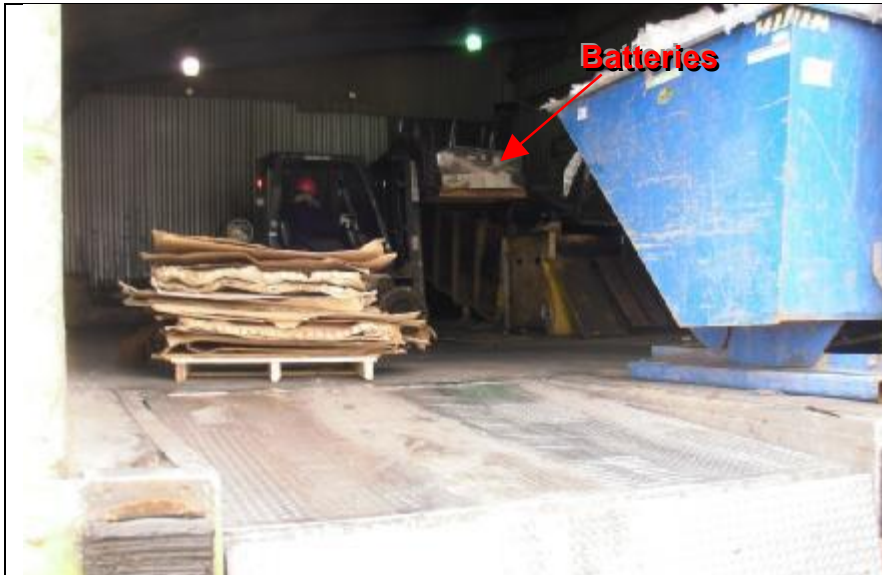
The EPA Contract Inspector observed, during the inspection, additional regulated industrial activities that included recycling lead acid batteries to recover lead and plastic (refer to Photographs 5 and 6); activities that are categorized under SIC Code 5093 – Scrap and Waste Materials. Mr. Mopas explained that lead acid batteries are processed using a hammer mill and the lead is separated from the plastic. The secondary lead smelter is then used to refine the lead back to a pure form as lead ingots, the finished salable product. Based on these activities and SIC Codes, the entire Exide site is an industrial facility as specified in Attachment 1 of the Permit.

Photograph 5 – View of batteries being placed in the battery dump bin from the battery recycling delivery dock.

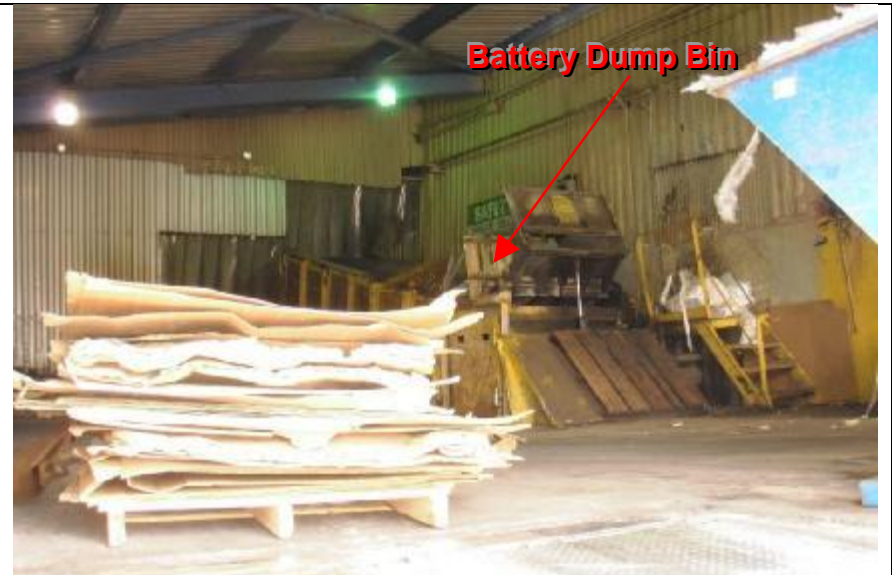
Photograph 6 – View of battery dump bin from the battery recycling delivery dock.

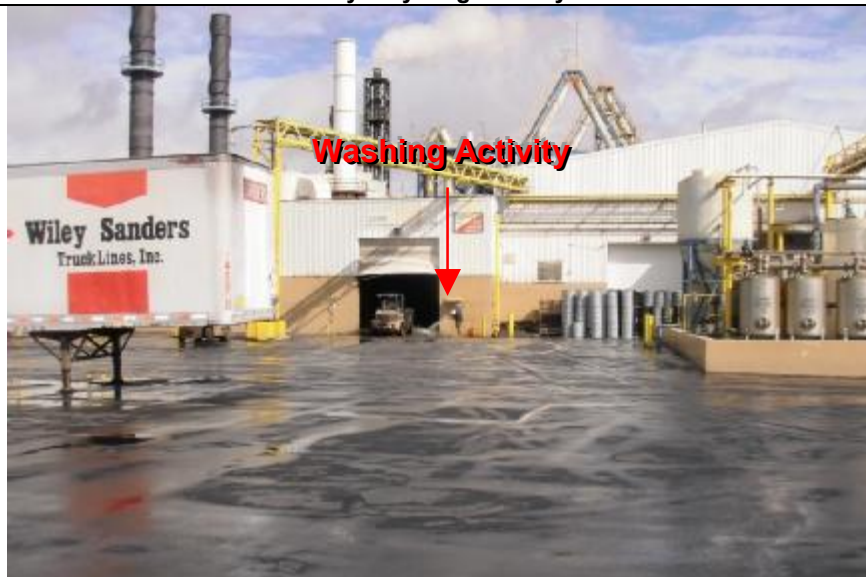
1. The EPA Contract Inspector observed, during the inspection, equipment and pavement washing activity outside the blast furnace feed room in an area of the Facility that Mr. Mopas referred to as the “North Yard” (refer to Photographs 7 and 8). Wash water was flowing through a scrap iron stockpile (refer to Photograph 9), along the Union Pacific and Santa Fe Railroad tracks, and toward the railway exit along South Indiana Street (refer to Exhibit 1). Because the railway is traveled by railcars which are loaded with finished product at the loading dock adjacent to the blue lead warehouse (refer to Exhibit 1), this railway itself is also an area of industrial activity. Although a berm and trench drain were present along the railway exit, there was a potential for locomotive and railcar contact with the wash water accumulated along the tracks, and subsequent tracking onto South Indiana Street (refer to Photographs 10 and 11). Rail

Photograph 7 – View facing north at equipment and pavement washing activity outside the blast furnace feed room.

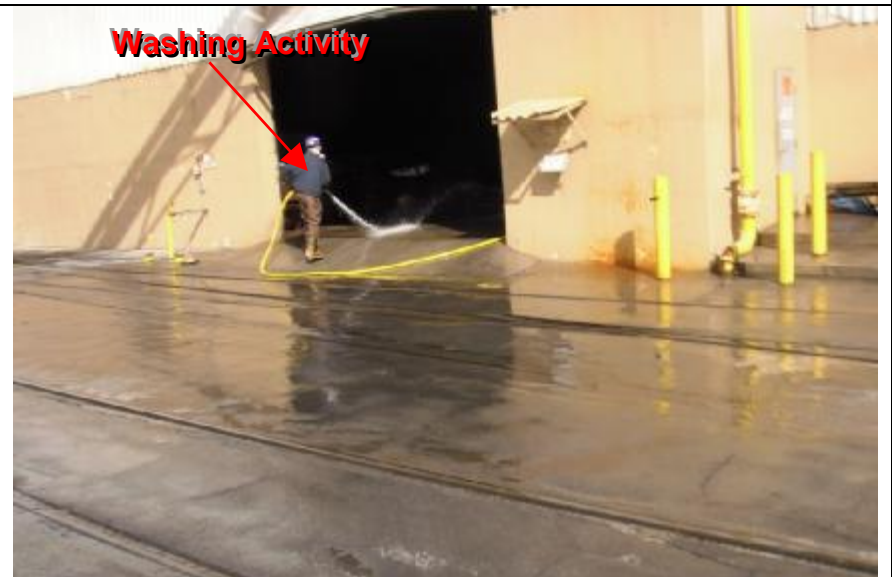
Photograph 8 – Close-up view of washing activity facing northwest.

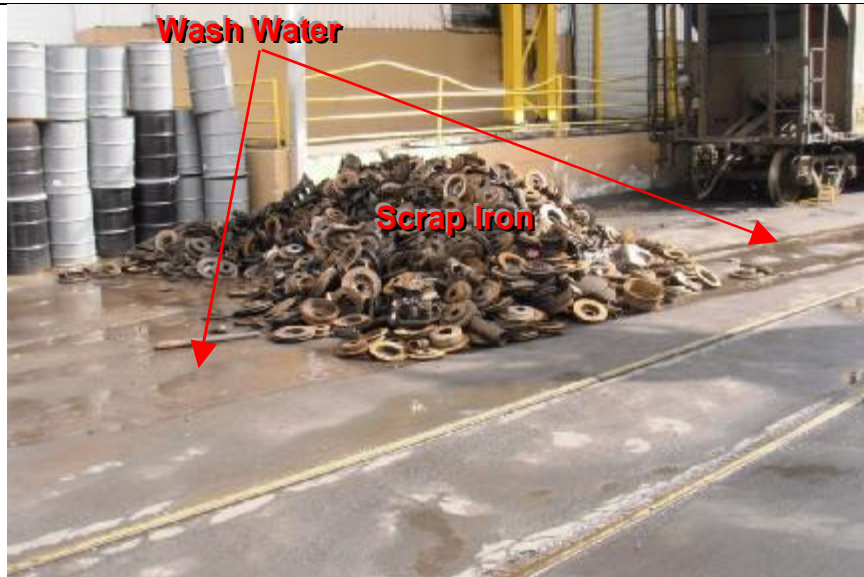
Photograph 9 – View of wash water (shown in Photograph 8) flowing through a scrap iron stockpile, facing east.

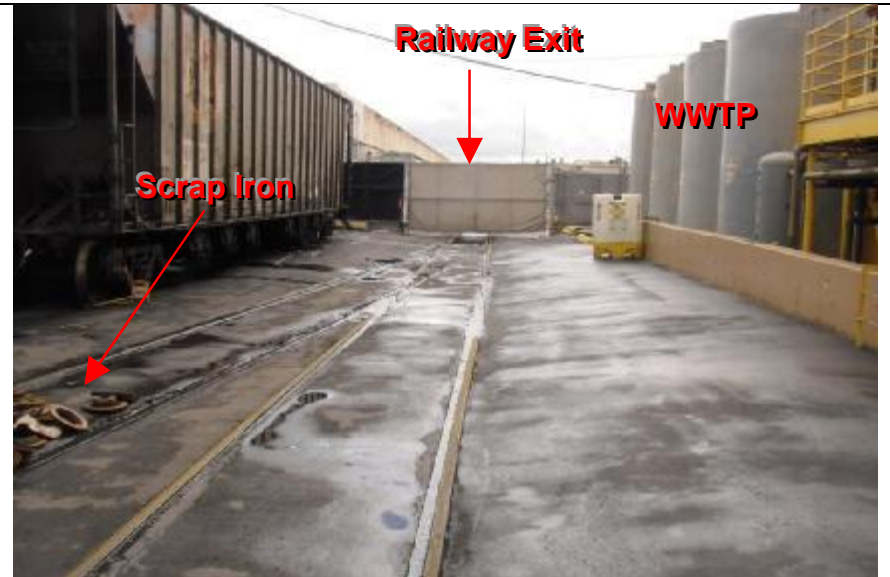
Photograph 10 – View toward the railway exit along South Indiana Street, facing southeast.

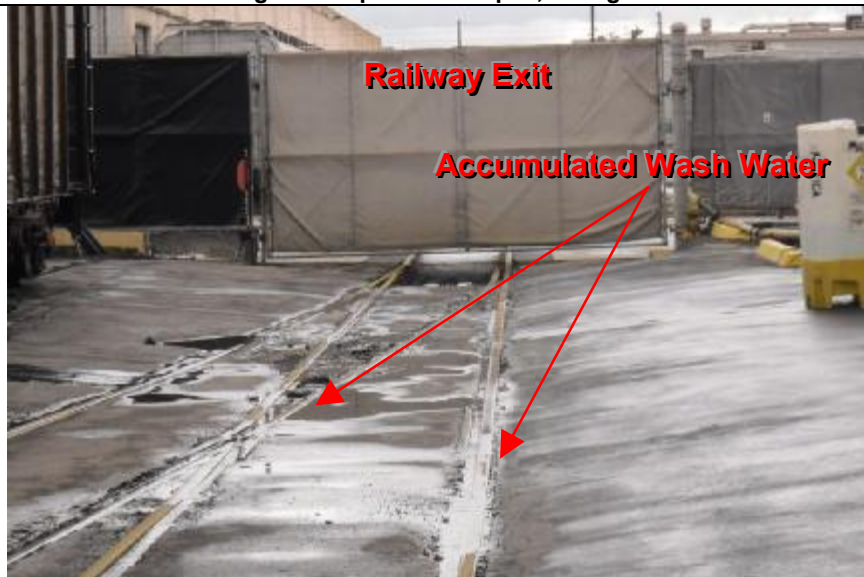
Photograph 11 – Close-up view of accumulated wash water along the tracks, facing southeast.

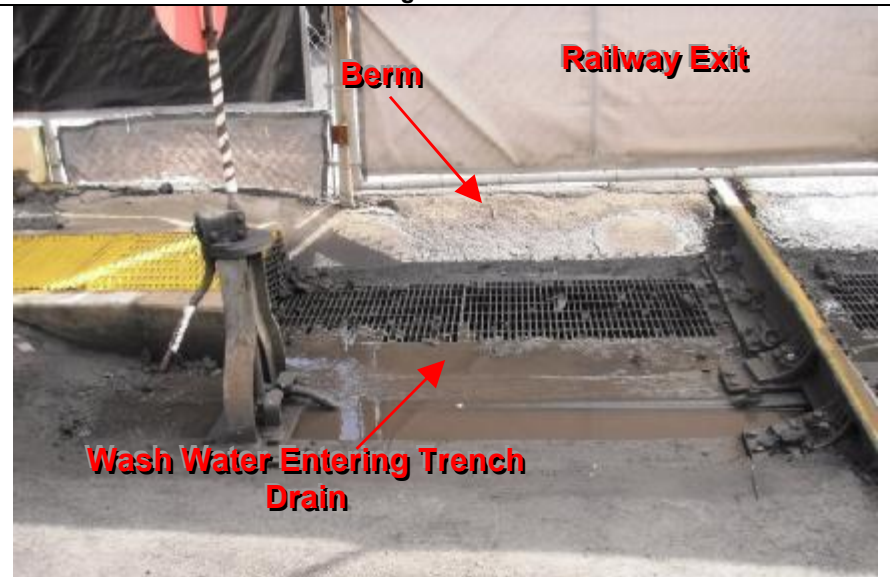
traffic and subsequent tracking were not observed during the inspection. Due to the lack of rail traffic, wash water was observed flowing into the trench drain adjacent to the railway exit along South Indiana Street (refer to Photographs 12 and 13). Based on the drawings provided and reviewed after the inspection, the EPA Contract Inspector could not verify that this trench drain is connected to the WWTP collection system.

Photograph 12 – View of wash water flowing into the trench drain adjacent to the railway exit, facing southeast.

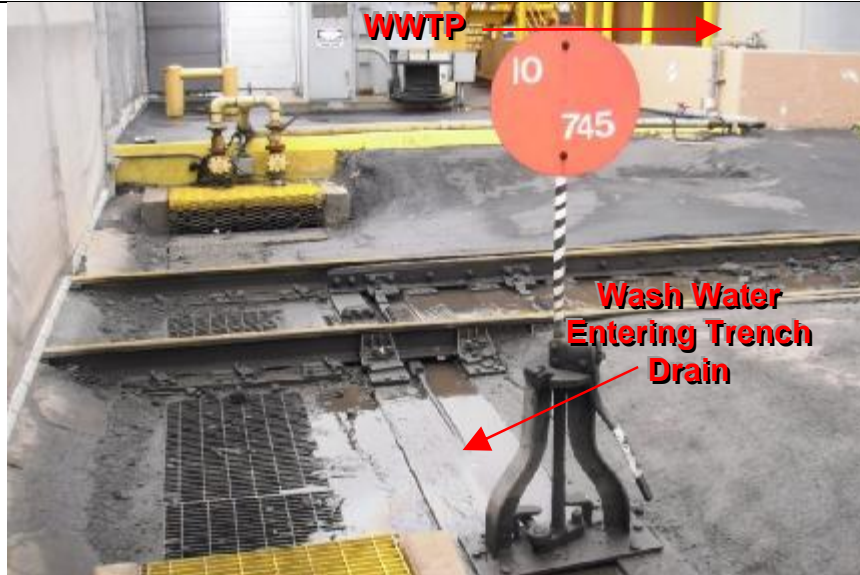
Photograph 13 – View of wash water flowing into the trench drain adjacent to the railway exit, facing southwest.

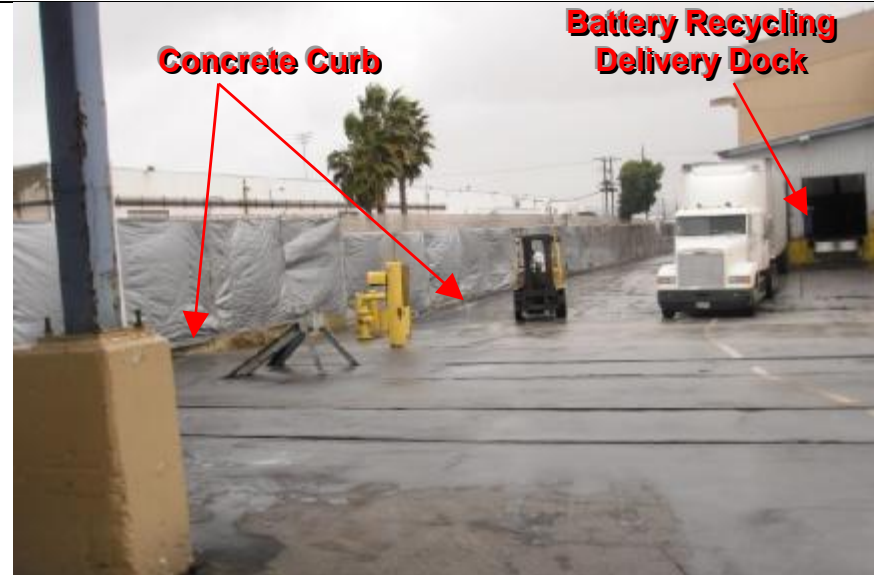
2. The EPA Contract Inspector observed, during the inspection, that the concrete curb along the drainage channel in the North Yard was damaged (refer to Photographs 14 and 15). Specifically, cracks were present in the concrete curb at multiple locations, possibly compromising the structural integrity of the curb (refer to Photographs 16 through 18). Due to the damaged concrete curb, there was a potential for storm water to pass through the curb and enter the adjacent drainage channel which serves as the western border of the North Yard.

Photograph 14 – View of concrete curb from inside the North Yard, facing northwest.

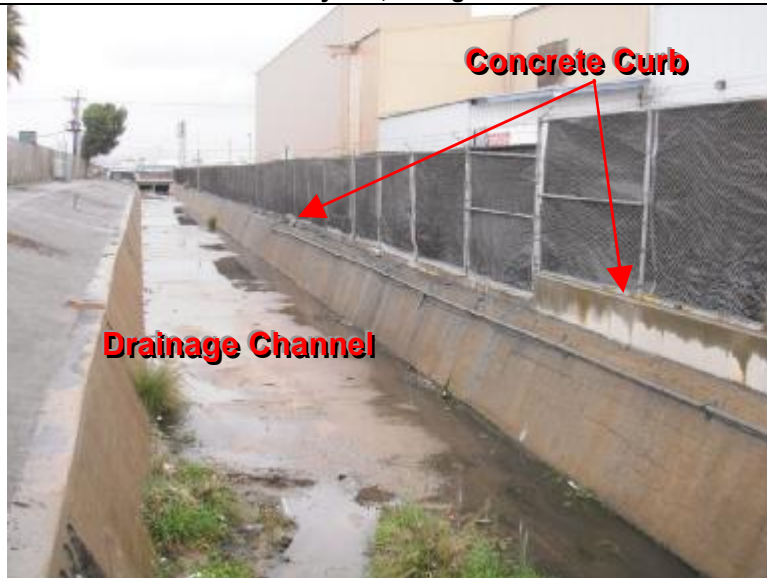
Photograph 15 – View of concrete curb from bridge over the drainage channel in the North Yard, facing north.

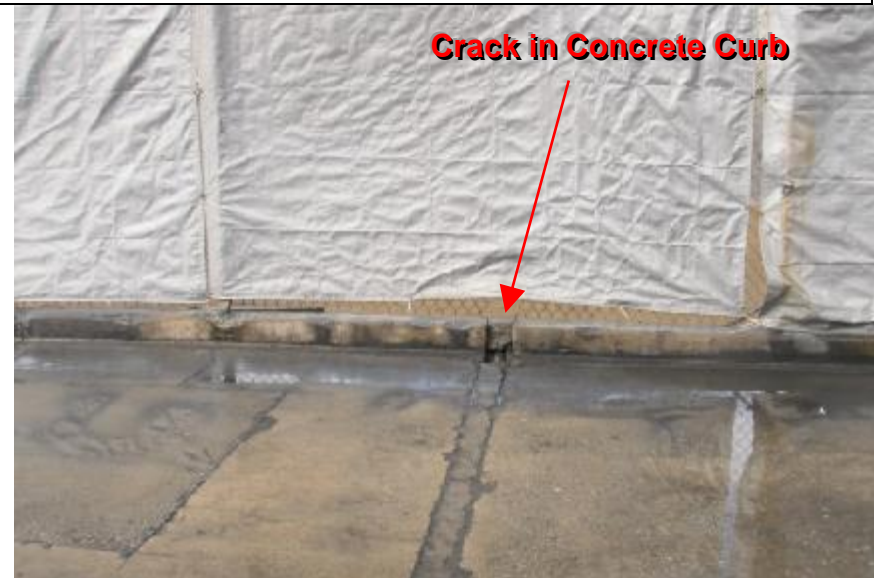
Photograph 16 – View of crack present in the concrete curb adjacent to the battery recycling loading dock, facing west.

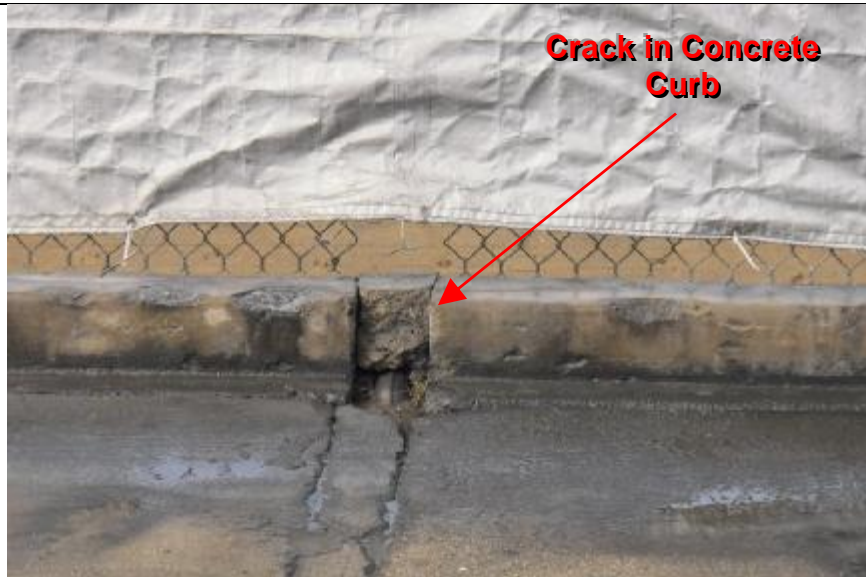
Photograph 17 – Close-up view of crack shown in Photograph 16.

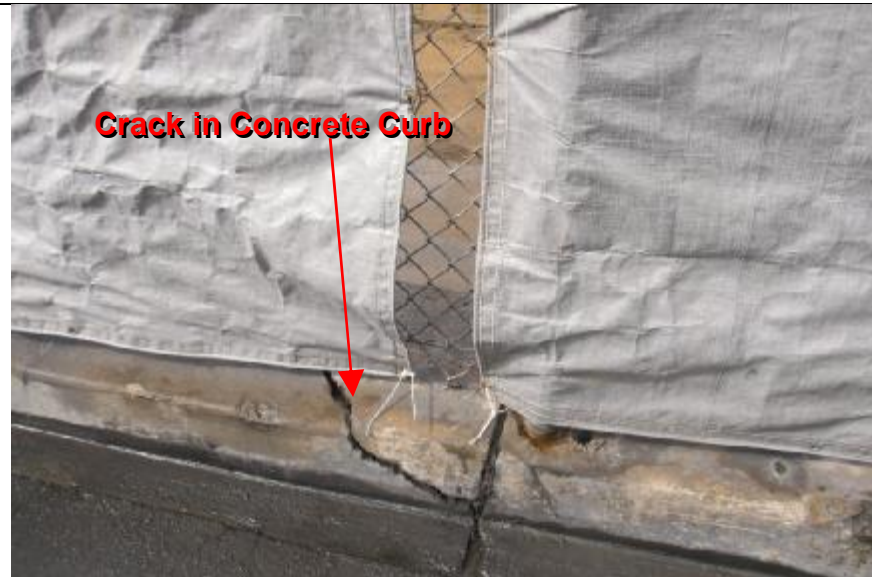
Photograph 18 – View of another crack present in the concrete curb to the north of Photograph 17, facing northwest.

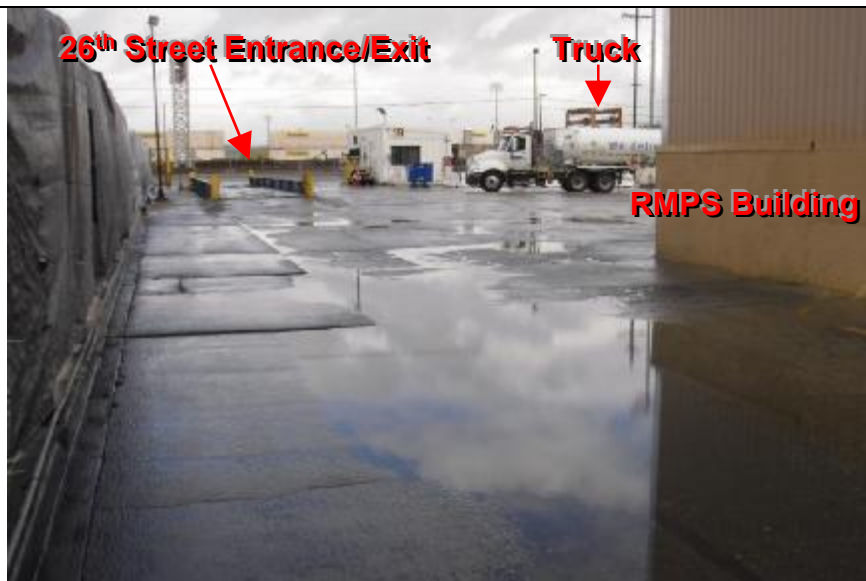
Photograph 19 – View from the west side of the RMPS building facing northeast. Note truck traffic exiting the Facility.

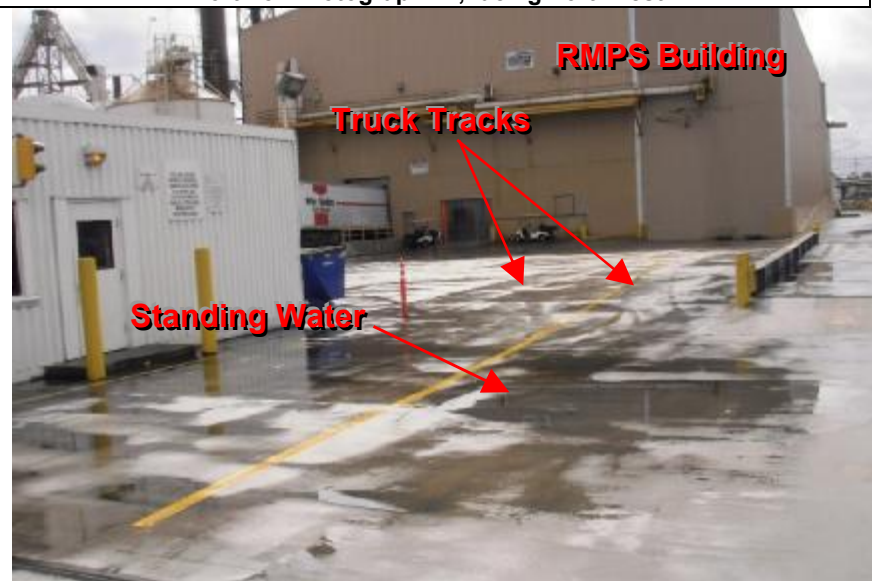
3. The EPA Contract Inspector observed, during the inspection, that storm water had been tracked outside the Facility at the 26<sup>th</sup> Street entrance/exit located in the North Yard (refer to Exhibit 1). Mr. Mopas explained that the 26<sup>th</sup> Street entrance/exit is used to transport finished product, and that truck traffic is not allowed in the area to the west of the Raw Material Processing System (RMPS) building (refer to Exhibit 1). Truck traffic was observed exiting the Facility through an area of standing water (refer to Photographs 19 and 20), and subsequently tracking storm water onto 26<sup>th</sup> Street (refer to Photographs 21 and 22).

Photograph 20 – View of 26<sup>th</sup> Street entrance/exit, facing southeast. Note presence of truck tracks and standing water.

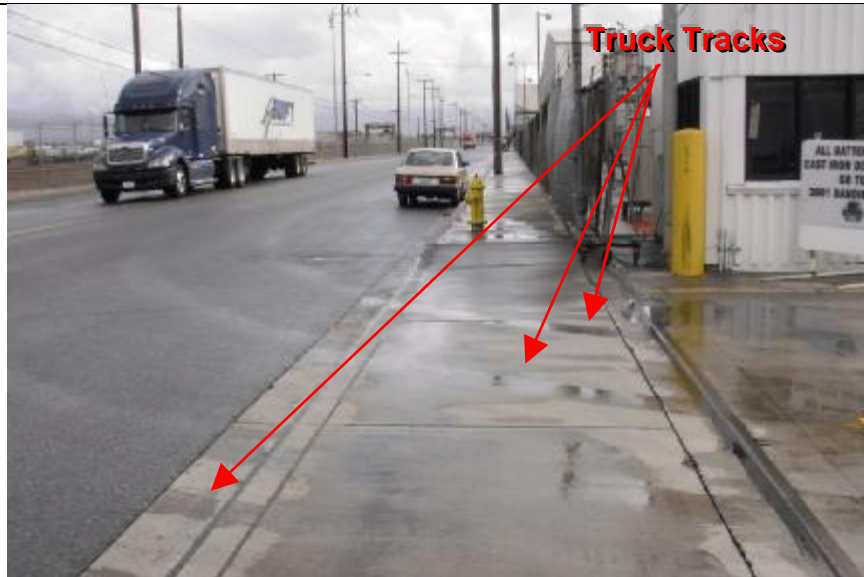
Photograph 21 – View of 26<sup>th</sup> Street entrance/exit, facing east. Note truck tracks and storm water leading from the Facility.

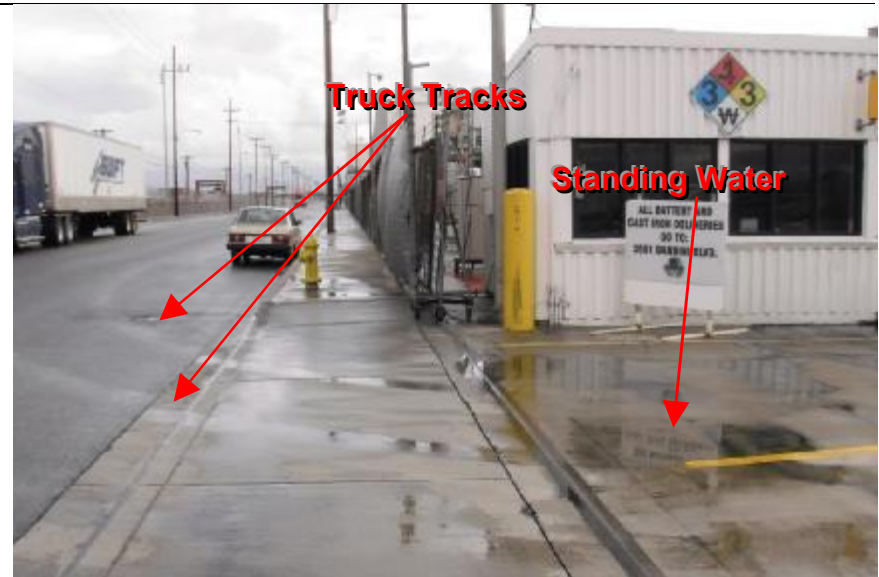
Photograph 22 – View of 26<sup>th</sup> Street entrance/exit, facing east. Note truck tracks and storm water leading from the Facility.

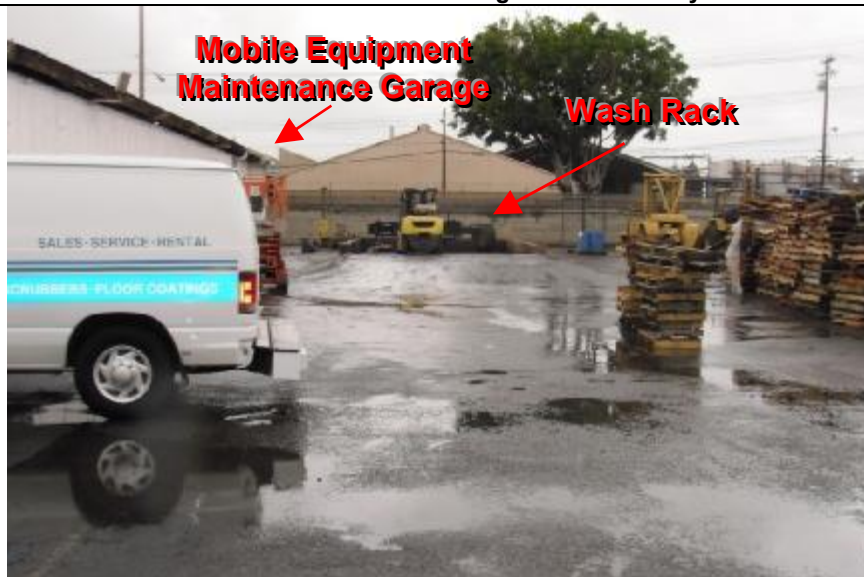
4. The EPA Contract Inspector observed, during the inspection, two vehicle and equipment wash facilities. A mobile equipment (e.g., forklift) wash rack is located to the west of the Mobile Equipment Maintenance Garage in the West Yard (refer to Exhibit 1 and Photographs 23 through 24). In addition, a vehicle wheel wash facility was present northeast of the Bandini Boulevard entrance/exit in the West Yard (refer to Photographs 25 through 26). Mr. Mopas explained that the vehicle wheel wash facility was approximately one year old, and that scale house staff ensure that vehicles use the wheel wash prior to exiting onto Bandini Boulevard. The industrial wastewater discharge permit (Permit No. 15725) with LACSD indicates that truck wash water is permitted for pretreatment at the WWTP. However, based on the drawings provided and reviewed after the inspection, the EPA Contract Inspector could not verify that these two vehicle and equipment wash facilities are connected to the WWTP collection system.

Photograph 23 – Mobile equipment wash rack located to the west of the Mobile Equipment Maintenance Garage, facing south.

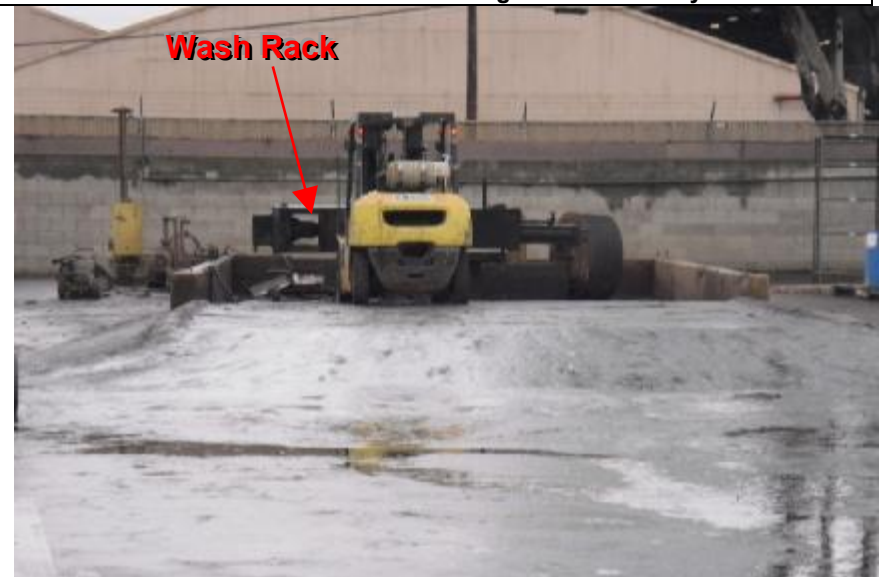
Photograph 24 – Close-up view of mobile equipment wash rack shown in Photograph 23.

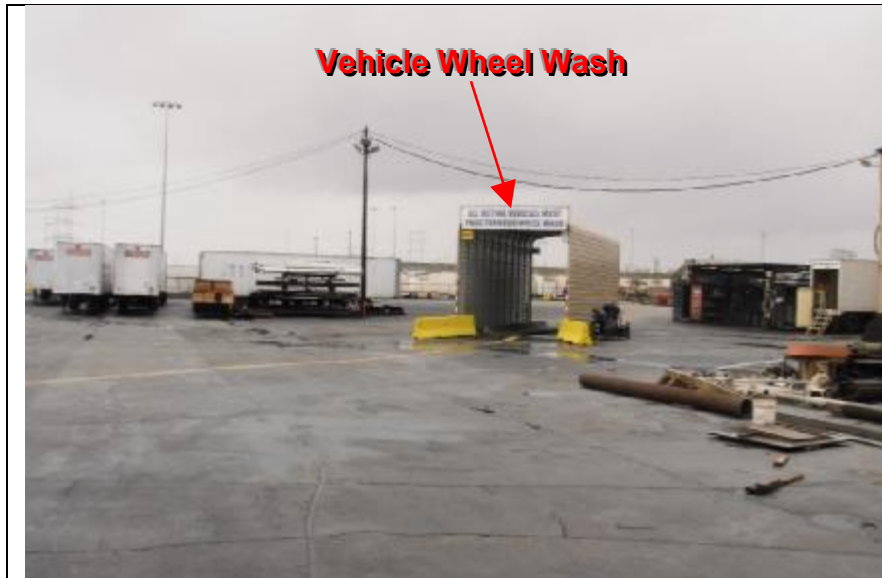
**Photograph 25 – Vehicle wheel wash facility northeast of the Bandini Boulevard entrance/exit, facing west.**

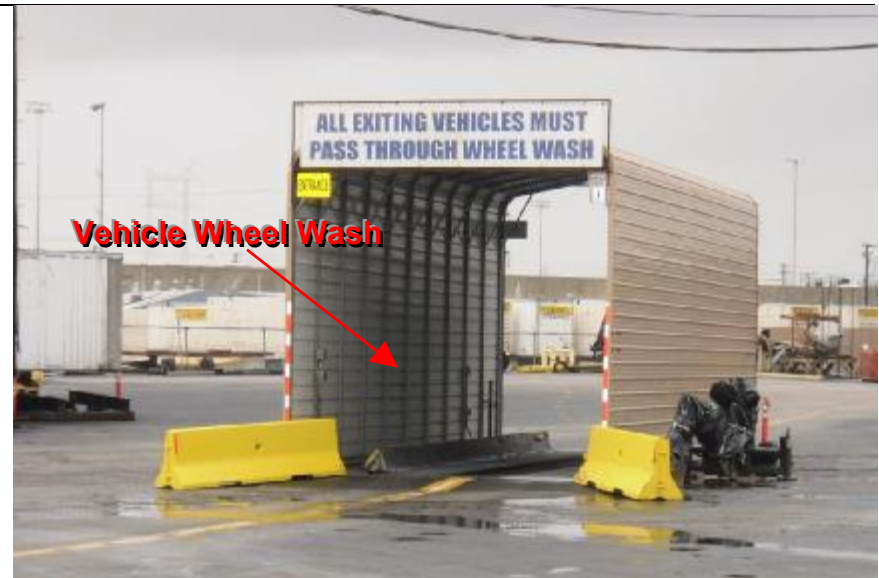
**Photograph 26 – Close-up view of vehicle wheel wash facility shown in Photograph 25.**
